# **Flashjet® Mobile Manipulator Development Project**

**Project Sponsor: CNO N45**  
**Project Lead: NAVAIR Depot Jacksonville**  
**Prime Contractor: Flash Tech, Inc.**  
**Robot Sub-Contractor: PaR Systems, Inc.**

## **Phase III Demonstration Final Report**

**July 14<sup>th</sup>, 2003**

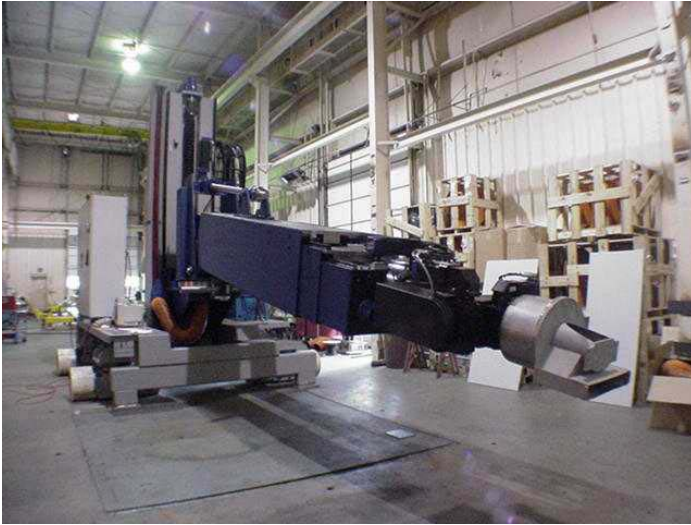
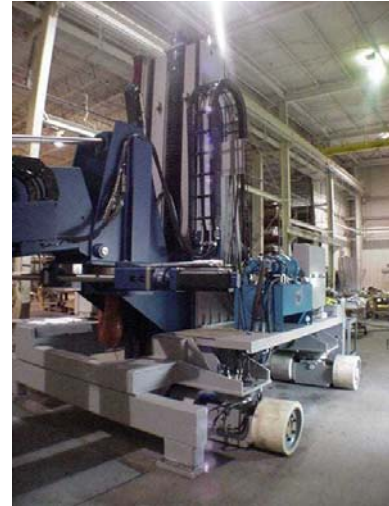
**Plate 2: Phase I Mobile Manipulator**

Key features of the mobile manipulator are:

*Cart Control:* Drives cart through a hand held pendant at rear end of cart. Cart has four sets of wheels and is driven by hydraulics through two wheel sets. Opposite wheel sets are idlers. Due to the unique design, cart is capable of being driven in any direction. Wheel sets can be extended to move and retracted to establish robot control over a sturdy three-point base.

*Robot Control:* A hand held pendant at robot end of cart allows operator to teach and program aircraft surface areas through three dimensions. Robot controls seven robot axis movement and is interlocked with cart pendant to ensure no dual movement.

- 1st axis: Boom rotate – 45 to + 45
- 2<sup>nd</sup> axis: Boom pivot – 15 to + 60
- 3<sup>rd</sup> axis: Boom extend to 27 feet
- 4<sup>th</sup> axis: Theta 1 (yaw) – 185 to + 185
- 5<sup>th</sup> axis: Theta 2 (pitch) – 135 to + 135
- 6<sup>th</sup> axis: Theta 3 (roll) – 225 to + 45
- 7<sup>th</sup> axis: Boom elevator to 11 feet

- Manual Emergency Stop
- Laser beam E-stop switch located along underside of boom
- Halo (360) E-stop protection around Flashjet head.
- Remote boom cameras enhance operator control/visibility.

*Flashjet® Process Control:* Windows Driven System w/remote control console providing full status, interlock and control of support systems as well as robot control and program review features. Laser stand-off distance sensors provide teach and auto surface tracking capability. Color vision sensing system provides auto-selective strip capability. IR scanning system provides surface temperature monitoring, control and track history.

Subsequently, PaR systems was given approval to design and build the manipulator. (*See Plate 2 to for pictures of Mobile Manipulator with design features description.*) This resulted in a successful demonstration of the new manipulator (with mock-up of flashjet head) using a full-scale P-3 model of a fuselage and wing section on August 7<sup>th</sup>, 2001. During the demonstration safety features and interlocks of the mobile system were fully demonstrated. Both project manager and the Boeing Company (Prime Contractor) witnessed this demonstration. A video of the demonstration effort is available for review.

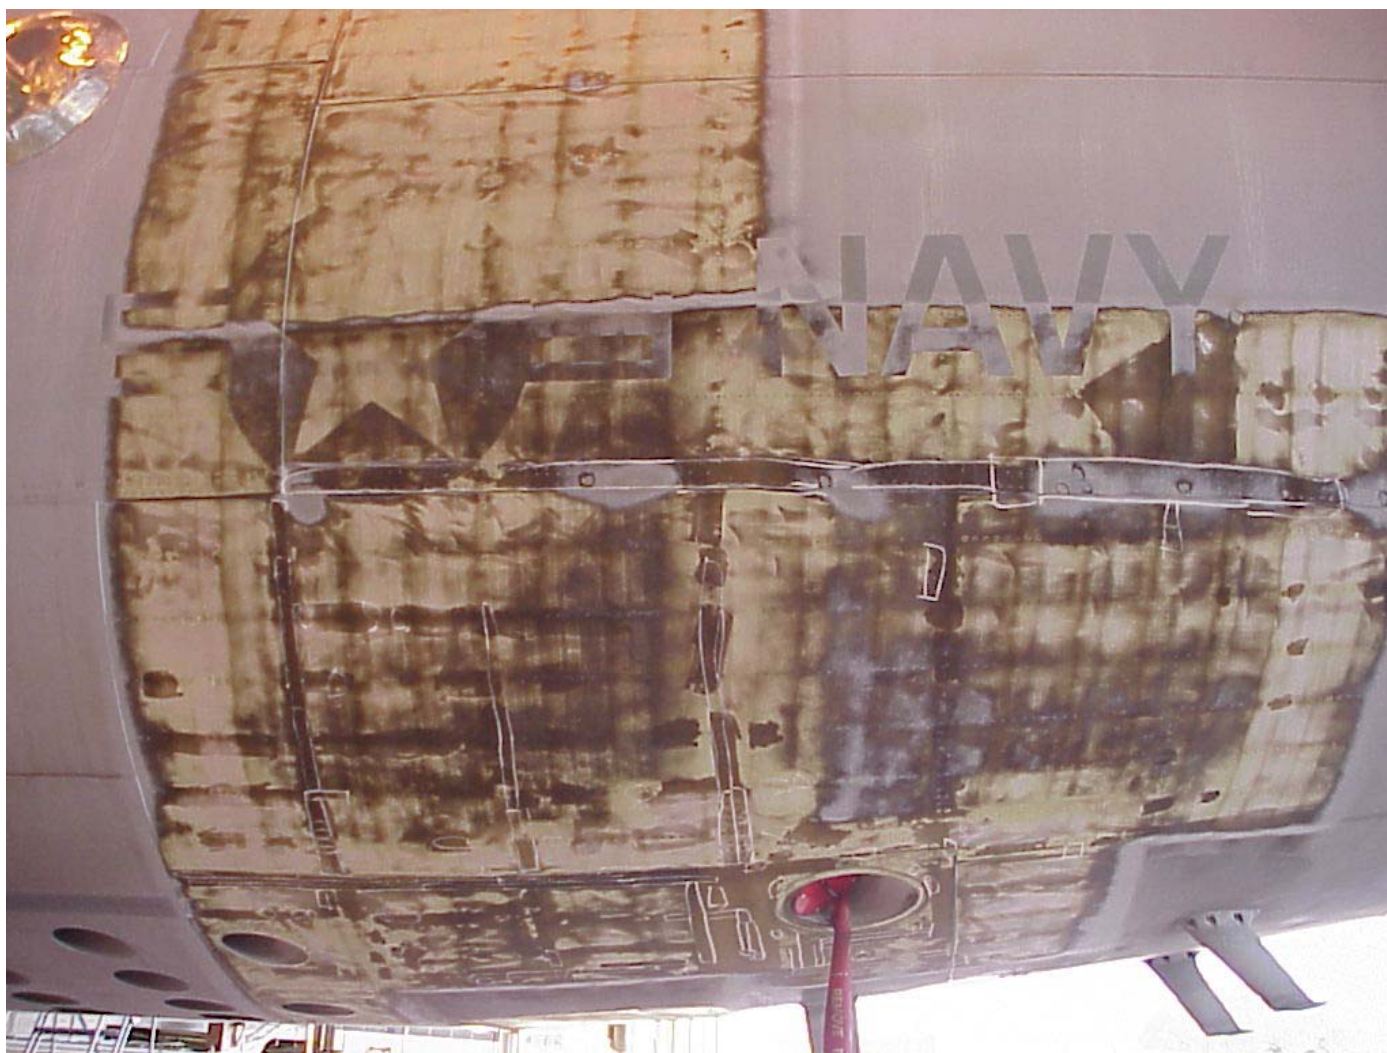
**Mobile Flashjet® Phase III Demonstration Report**  
**Plate 16: Completed Flashjet Strip of Aft Port Fuselage**

Note: (1) The above picture is a typical result of the flashjet® process over an aircraft which has been “seasoned” by field service repair. During demo the MFJ temperature control feature was set at 250F. Dark brown areas indicate thermally damaged conversion coat at the 250F setting. Lab panel test at right confirms thermal damage (*on right*) at temperature of 250F. (2) Identified chalked areas are the result of a corrosion inspection that identified these areas as positive for corrosion and will requiring glass bead blast to treat these corrosion sites. (3) The area around the lower right antennae is representative of the limit of FJ to reach/strip around obstructions but demonstrates FJ capability to “feather edge” strip areas into painted areas typically done by hand sanding.

- The flashjet® process was found to thermally degrade the aircraft's chromate conversion coating in areas of in service repair for corrosion (*See Plate 16*). This deficiency necessitated that the damaged conversion coating be removed from these areas. Two available methods to remove this coating include (1) scotch brite cleaning [which was found to be labor intensive] or (2) use of chemical paint strippers. [Note, while the flashjet process was found to thermally degrade the aircraft's conversion coating, the metallurgical branch determined that the short time (approximately 1 sec) of thermal exposure at moderately low temperatures was not a concern with respect to substrate materials property effects.]

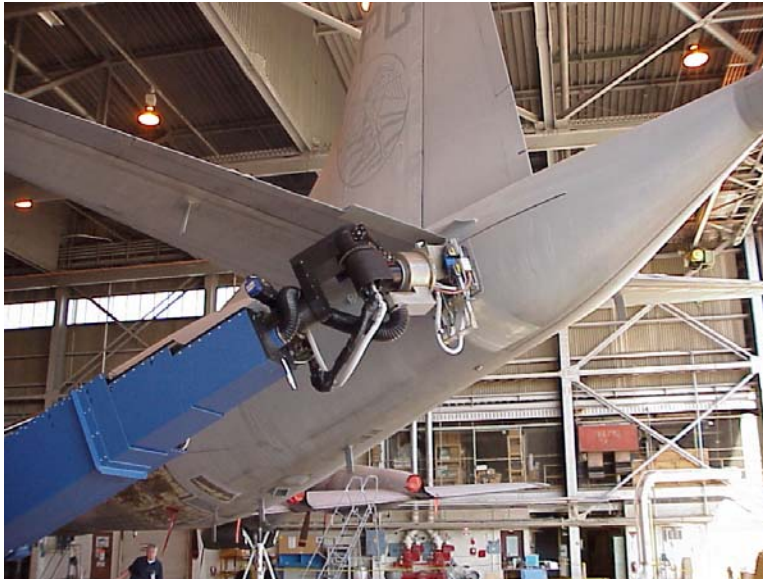
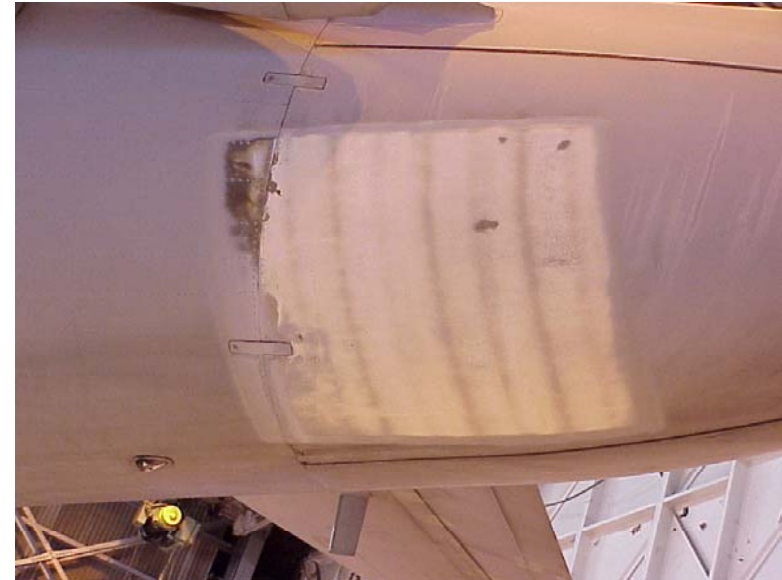
**Mobile Fashjet® Phase III Demonstration Report**  
**Plate 17: Completed Strip of P-3 Composite Stinger**

Notes: The flashjet strip process yields a uniform and damage free strip of P-3 (Honey-Comb Fiberglass) stinger. Materials lab subsequently recommends that epoxy and polyester fiber reinforced plastic (composite materials) structures/components should be considered for coating removal by FlashJet and that ideal candidate are those currently showing difficulty and damage with existing chemical, PMB or hand sanding depaint process methods.

Although Flashjet® is not recommended for aircraft paint strip operations, based on the demonstration strip of the P-3 tail radome (stinger) it is recommended that the flashjet® process or other thermal method such as laser strip be pursued as an alternative for stripping composite surfaces such as the P-3 and EA-6B radomes, P-3 tail radome and other large composite aircraft surfaces. Additionally, the flashjet® process is specifically recommended for epoxy and polyester reinforced plastic (composite) surfaces which exhibit difficulty and/or damage with existing chemical, PMB, or hand sanding process methods. In these instances the flashjet® process can provide improved product quality and performance at potentially reduced cost. It is further recommended that such a facility be designed similar to the radome facility at Warner Robins AFB with capability to handle all radome work for the Navy. (See Recommendations section of this report.)

**5.7 Composite Strip Potential:** As a final and very significant finding, the materials lab determined that the flashjet® technology was very effective at removing the surface coating of the polyester fiber reinforced plastic of the P-3 tail radome “stringer”. (*Refer to Plate 17.*) See also MESR 03JX01532. Based on this data point, the materials lab recommended that the flashjet® process would be best suited for stripping composite surfaces such as the P-3 and EA-6B radomes, P-3 tail radome and other large composite aircraft surfaces and specifically those which exhibit difficulty and/or damage with existing chemical and/or PMB process methods. The materials lab further recommended that epoxy and polyester, fiber reinforced plastic (composite materials) structures and/or components should be considered suitable for coating removal by Flashjet® and that recurring problems with damage to such structures during coating removal with PMB, chemical and sanding processes could be significantly reduced or eliminated. It was noted, however, that Navair approval for subject composite surfaces is not available at this time and that specific NAVAIR approvals are needed before the flashjet® process could be fully employed in these instances.
